# The Vaccine and Infectious Disease Organization – International Vaccine Centre

# InterVac

Level 3 biocontainment  
facility built on U of S  
Campus

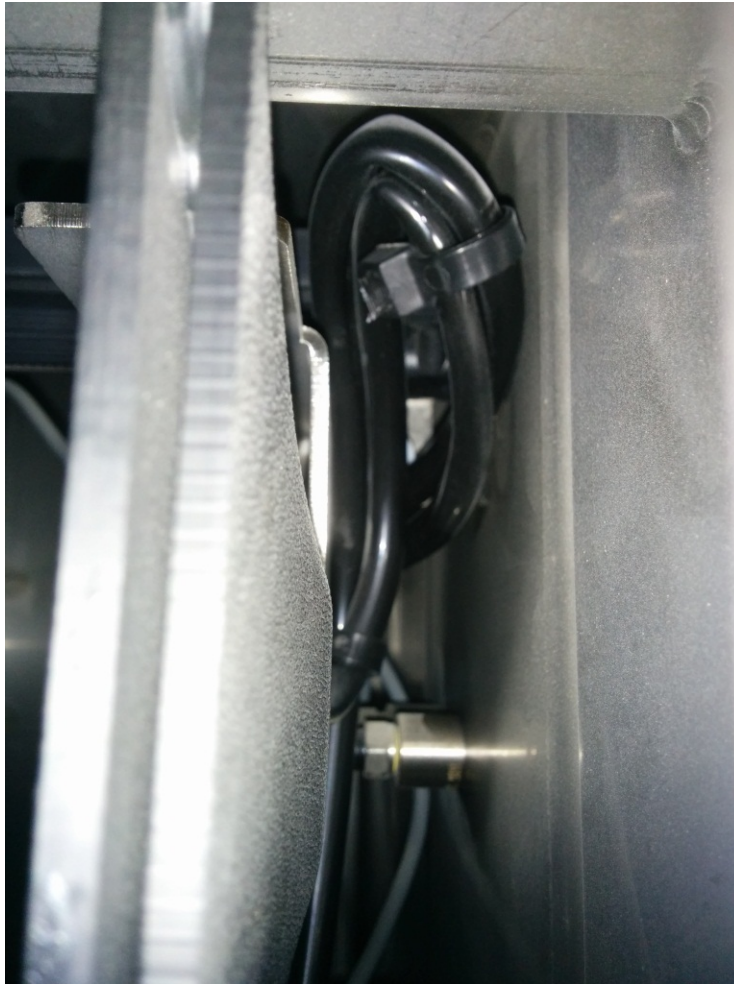
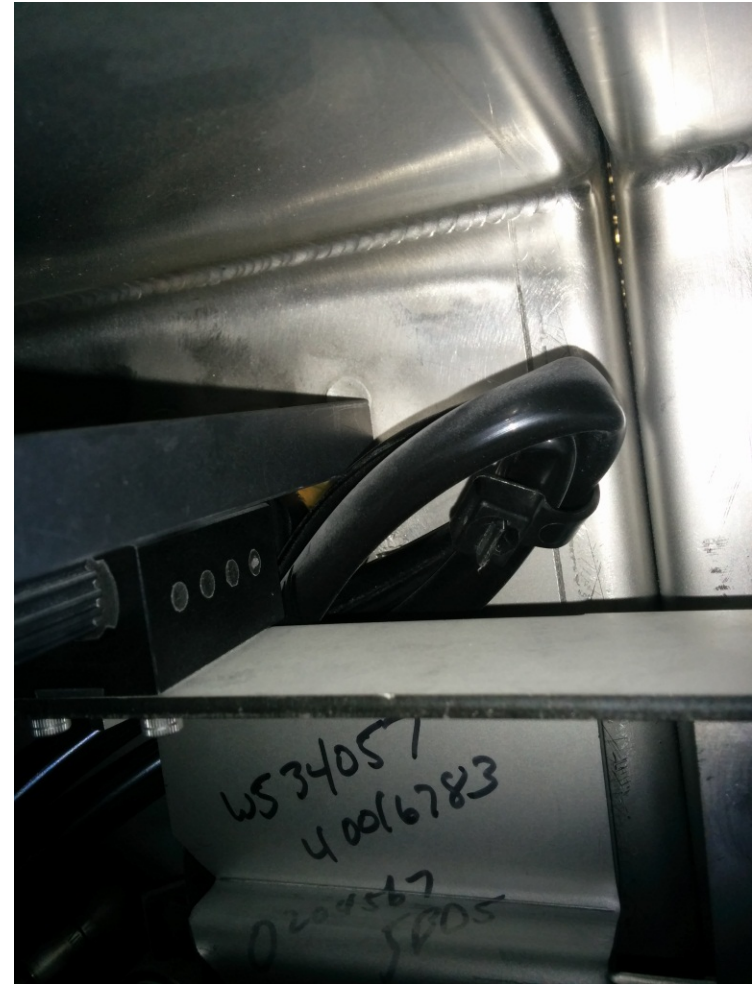
- getting caught under bottom probe guide
- getting caught between probe and prox sensor
- getting caught on damper support plate
- kinked hoses establish “memory”
- insufficient space for hose to gather

Hoses squeezed and kinked at end of scan run

- redesign of internal components and installation of hose loom
- site visit and remediation by Camfil
- longer hoses, better placement of gathers
- All accessible units refurbished; materials left for remainder

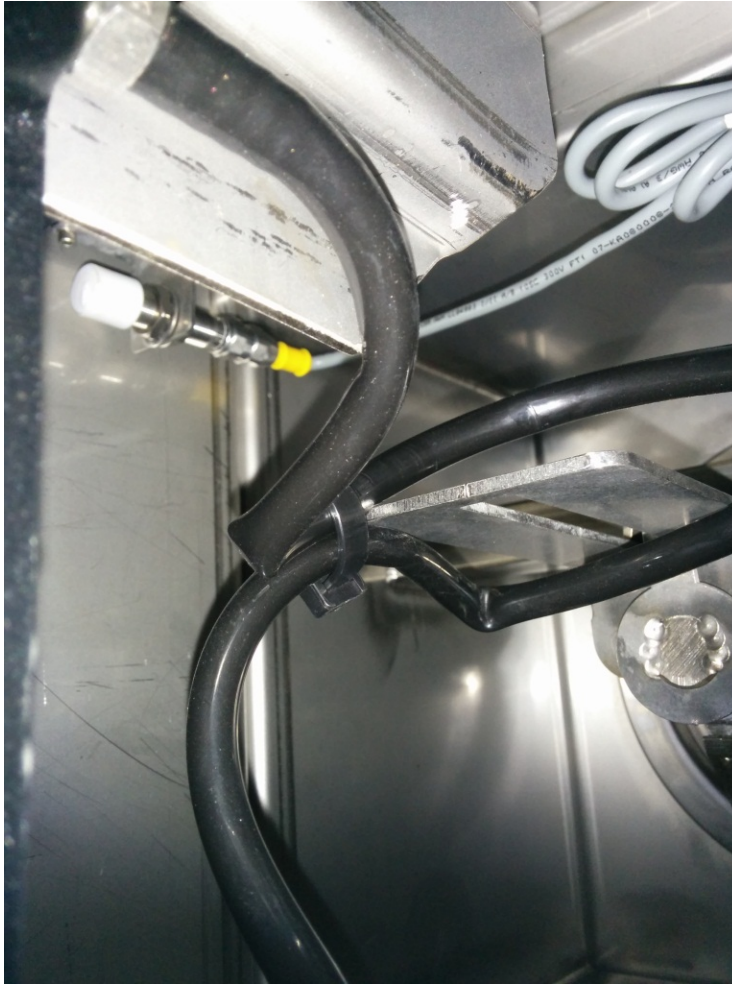
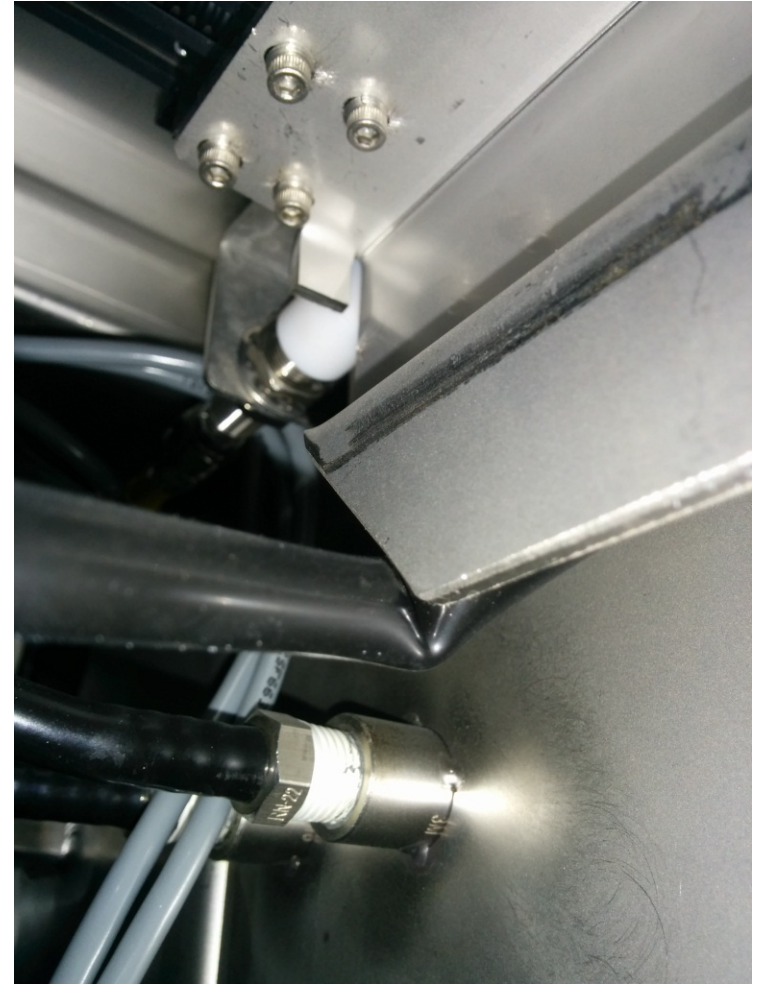
Hoses snagged on internal components and kinked

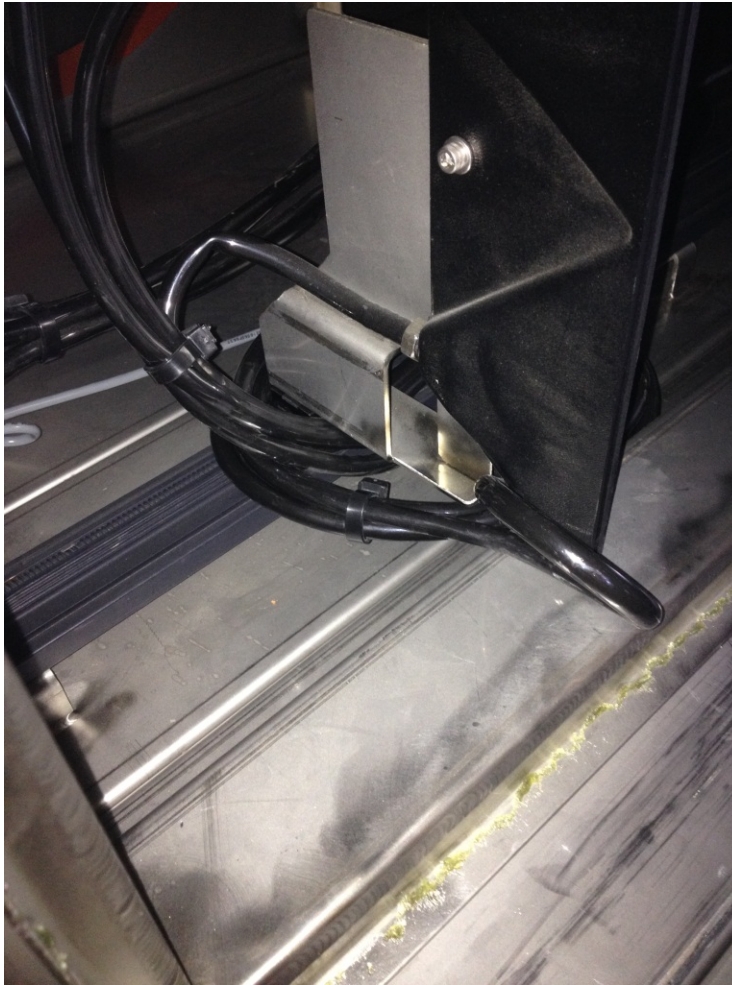
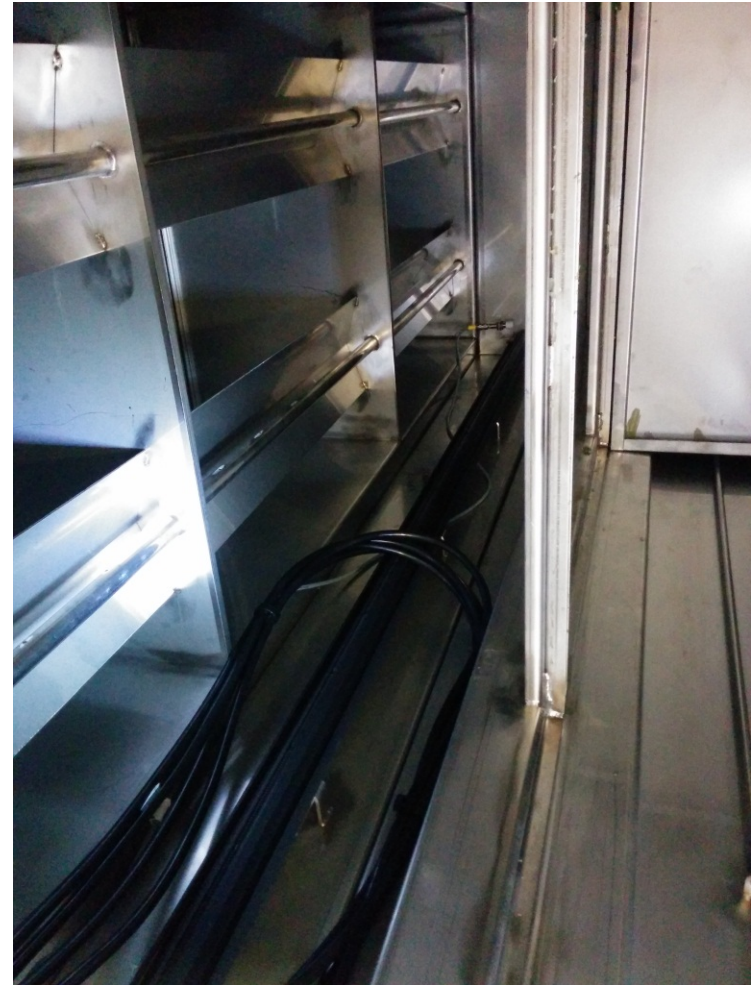
Hoses getting caught under track in triple wide filter housings

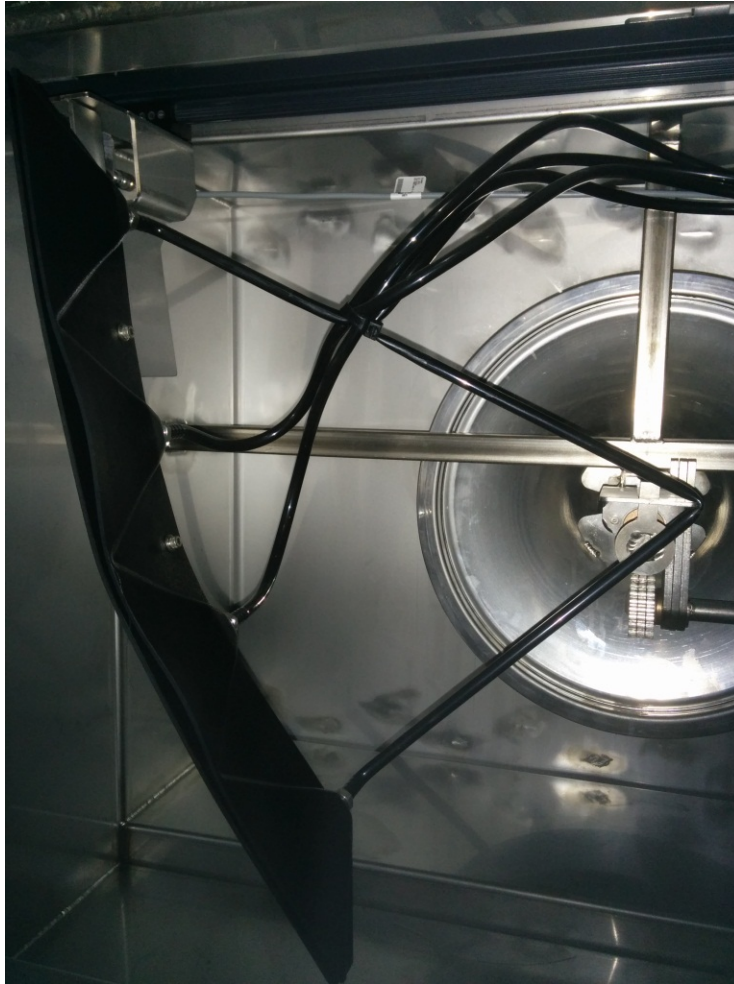
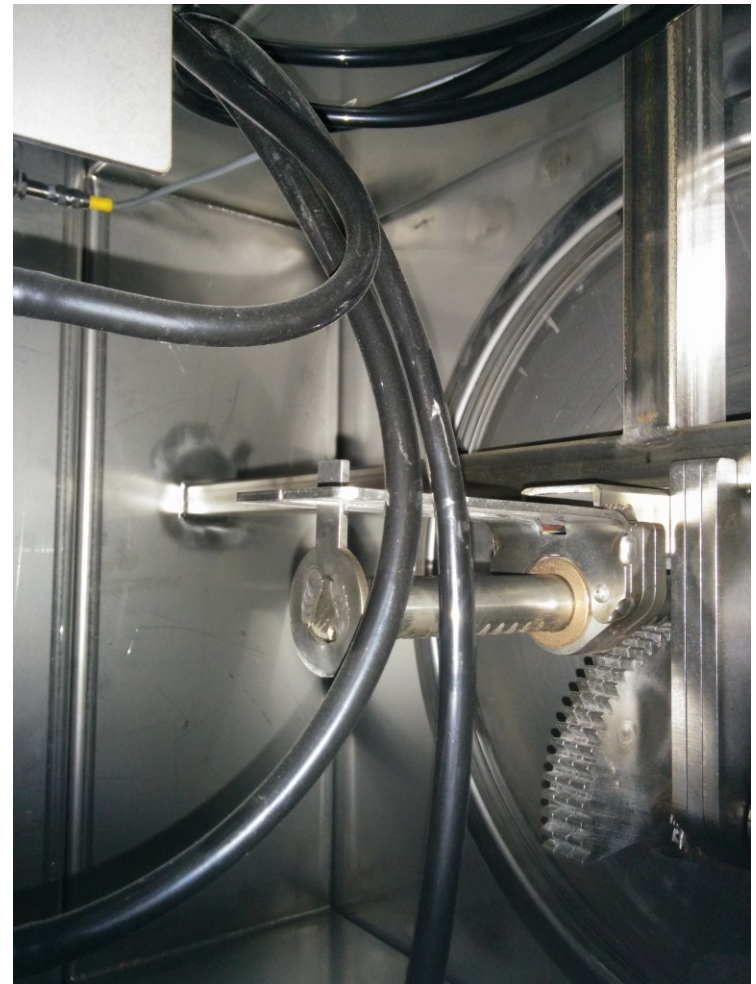
Extreme example of hoses catching on damper support place
